NASA Conference Publication 2190

Aircraft Engine Diagnostics

*A conference held at
Lewis Research Center
Cleveland, Ohio
May 6-7, 1981*

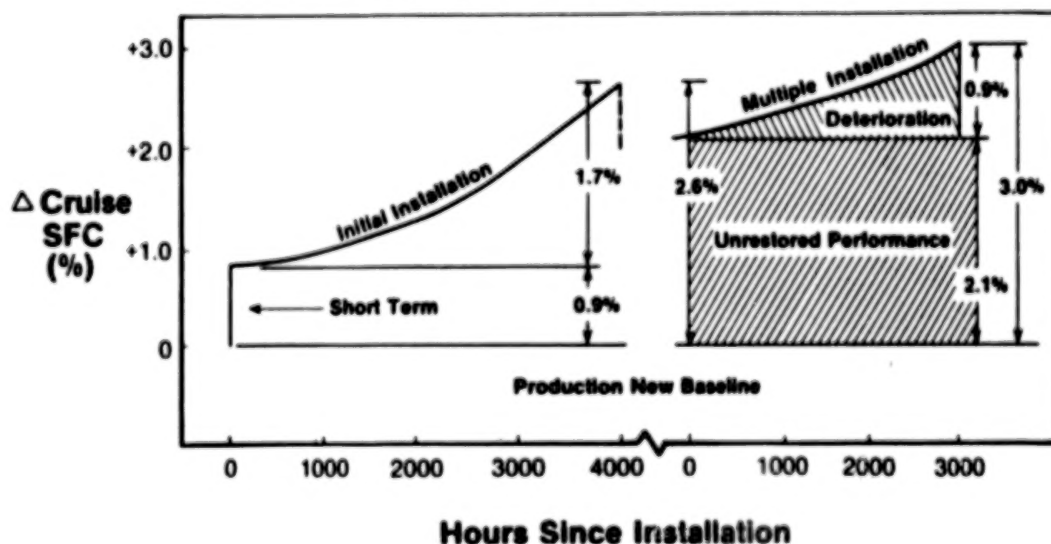
FIGURE 2

CF6-6D Performance Deterioration Characteristics

Figure 2 shows the resulting assessment of CF6-6D performance deterioration characteristics for the typical engine thru its initial installation and experience in review service and for the same typical engine after several multiple installations. Each of the elements of deterioration is presented in Figure 2 for the CF6-6D engine. This Figure shows equivalent cruise specific fuel consumption increases relative to a production new engine. The initial installation is shown on the left. Engines incur an average Short-Term loss of 0.9 percent prior to revenue service. During their initial installation, SFC increases an average of 1.7 percent based on the 4000-hour family of engines. The total increased SFC of the deteriorated engine is thus 2.6 percent from production new. Insufficient data is available to determine the amount of performance restoration during the first shop visit.

During the "nth" installation, the serviceable engine re-enters revenue service after a shop visit with an average unrestored cruise SFC loss of 2.1 percent. During revenue service, the cruise SFC of this multiple-build engine increases 0.9 percent for the 3000-hour engine. The total increased SFC of this deteriorated engine at 3000 hours was 3.0 percent from new. On the average, 0.9 percent cruise SFC is restored during the shop visit. During the next installation, an average revenue service deterioration of 0.9 percent is incurred. This amount is restored on the average during maintenance and the cycle is repeated.

Though engine-to-engine variations within this cycle are significant, the data presented reflects the typical or average engine deterioration characteristic for the CF6-6D engine.

The deterioration rates shown on Figures 2 and 3 are presented as a function of flight hours since installation. An analysis was conducted as part of the CF6-50 program, to understand the variability in deterioration rates which resulted from analysis of DC-10, 747 and A300B data. The conclusion was that deterioration rates for the data surveyed was most strongly influenced by average flight length per cycle and the amount of derate or reduced power being used by the individual operators. Table 1 shows the data from Figure 3 translated into the deterioration rate per 1000 cycles basis. The conclusion is that while the DC-10 and 747 data are reasonably consistent and show approximately the same deterioration rate per 1000 cycles, the A300B data shows a much lower deterioration rate per 1000 cycles. Since the A300B data studied as part of this program were consistent with flight cycle lengths of approximately 1.9 hours, the lower deterioration rate per 1000 cycles suggests that deterioration rates are not only influenced by numbers of cycles but also time at temperature.

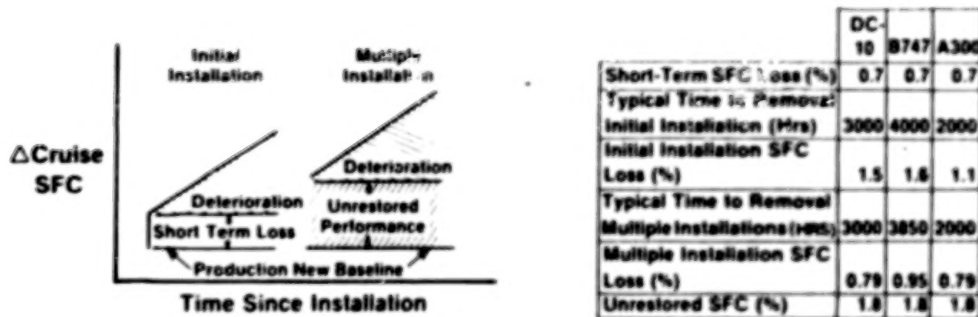
FIGURE 3

CF6-50 Deterioration Characteristics

Figure 3 shows the deterioration characteristics resulting from cruise data analysis of data obtained for the CF6-50 engine on various aircraft. General findings of the program were that the Short-Term losses which occurred during the airframer checkout of the aircraft tended to be the same for operation on all three aircraft. Also, the unrestored performance level of the multiple-build engine as refurbished by the various airlines was essentially the same. It can be noted from Figure 3 that the deterioration rate shown during typical 747 operation was lower than observed with DC-10 and A300 operations. The same relationship holds for both the initial and multiple

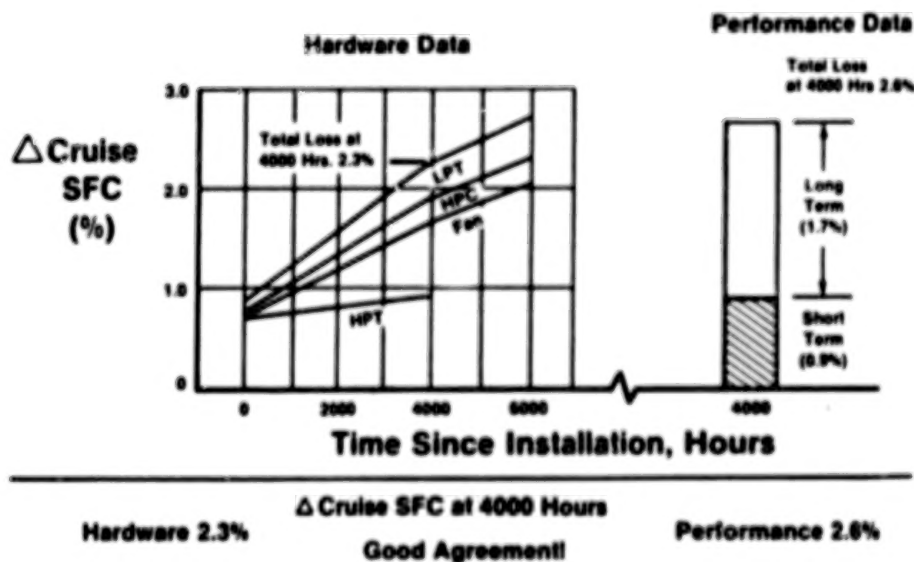
FIGURE 4

CF6-6D Initial Installation Performance Deterioration

Figure 4 illustrates the results of the hardware inspection analyses and the resulting deterioration model compared to the performance-data-derived deterioration level for the CF6-6D initial installation. It shows that the largest portion of the 0.9 percent Short-Term SFC loss resulted from High Pressure Turbine (HPT) performance losses. This loss was due largely to HPT clearance increases during the initial checkout phases of the airplane. During initial operation of the aircraft by the aircraft manufacturer, there is little attendant loss in fan, high pressure compressor and low pressure turbine. It is also to be noted that the combined performance deterioration level created by the stackup of the individual component deterioration losses at 4000 hours shows 2.3 percent total performance degradation from the "as new" condition compared to the 2.6 percent level which resulted from performance data analysis.

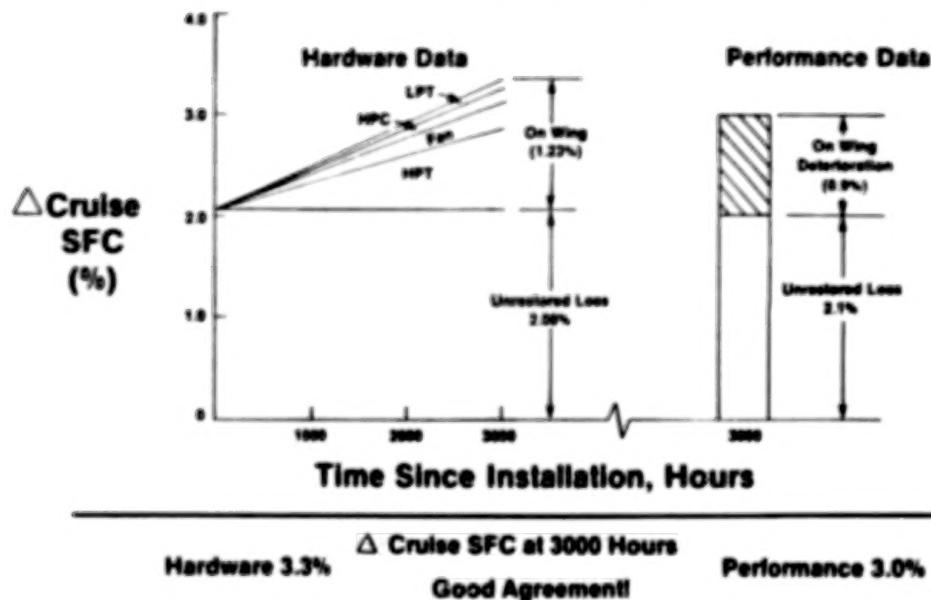
FIGURE 5

CF6-6D Multiple Build Engine Performance Deterioration

Figure 5 shows the deterioration mechanisms as assessed by hardware inspection for the CF6-6D multiple-build engines. The major deterioration of a multiple-build engine is within the HPT module. Typically, HPT performance is restored during every shop visit while fan, HP compressor and LPT performance levels are not. Therefore, each engine as it re-enters revenue service after an overhaul shop visit has new HPT hardware and somewhat deteriorated fan, HPC, and LPT performance levels. It can be noted again from Figure 5 that the results of the hardware inspection show 3.3 percent performance loss at 3000 hours on multiple-build engines compared to the performance data analysis level which indicated 3.0 percent. Again, agreement is good. Similar findings for losses associated with the initial installation and the multiple installations of CF6-50 engines resulted.

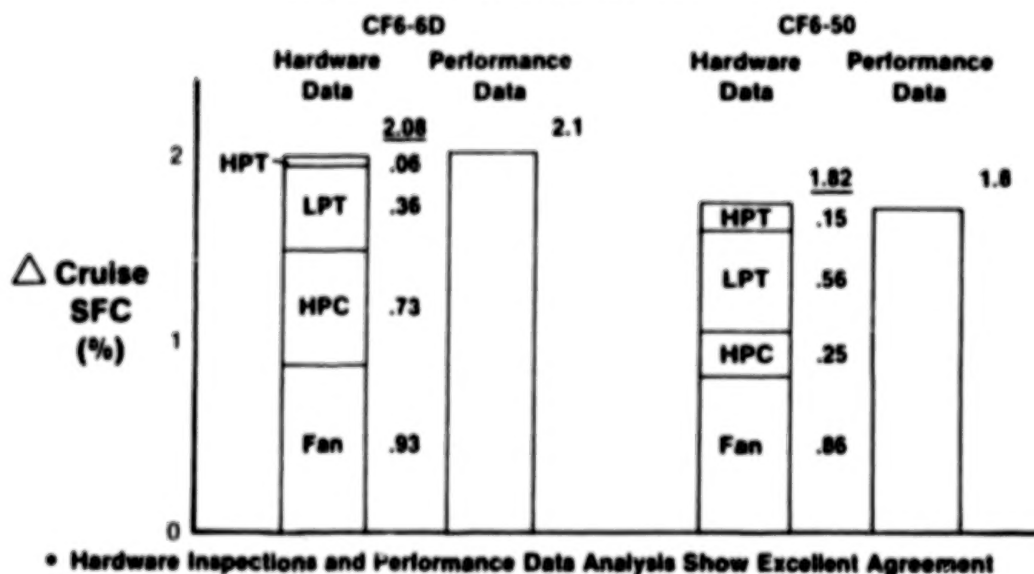
FIGURE 6

Unrestored Performance

Hardware Inspection Summary
Compared to Performance Summary

The unrestored performance identified in Figure 6 represents a potential gold mine in terms of fuel and dollars savings to the airlines, if it can be reduced on a cost effective basis. The presence of large amounts of unrestored performance associated with performance degradation of the fan module, HPC module and the LPT module, relative to new modular performance levels, is due to early workscope definitions. These airline shop overhaul work scope definitions were primarily aimed at maintaining reduced EGT levels and at restoring the condition of the hardware primarily from a reliability standpoint. The engine modules, which have the most direct impact on EGT margin and direct impact on reliability, are primarily associated with the hot section of the engine, the combustor and high pressure turbine area. Larger efforts (dollars and manhours) are required to achieve the same amount of EGT margin restoration in the LP system components than in the HP system components. In the early 1970's, it was concluded that it was not cost effective to do significant performance restoration in the fan and LPT areas with fuel prices at a 30 cents per gallon level. With current and projected fuel prices, the cost effectiveness of doing performance restoration work in all of the engines' major components must be re-examined.

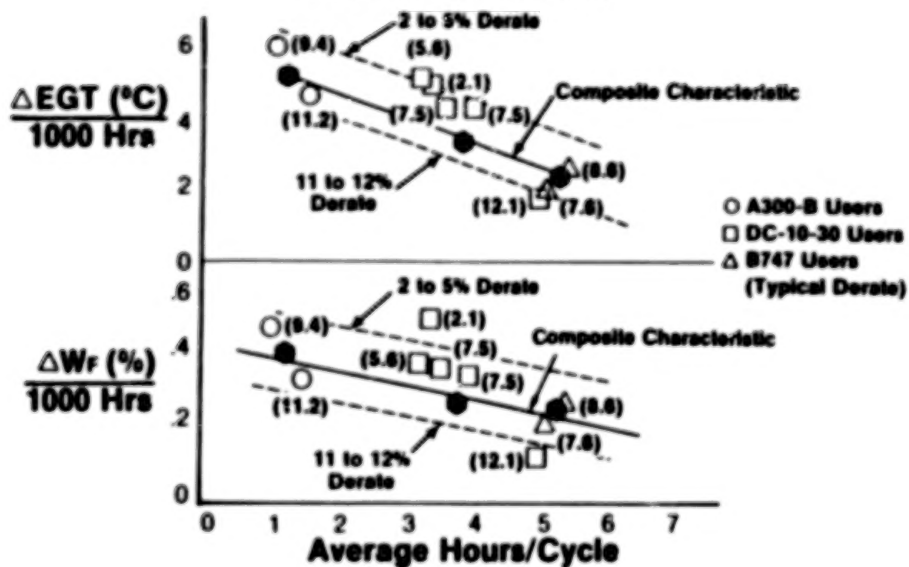
FIGURE 7

Effect of Flight Cycle Length and Derate on CF6-50 Performance Deterioration

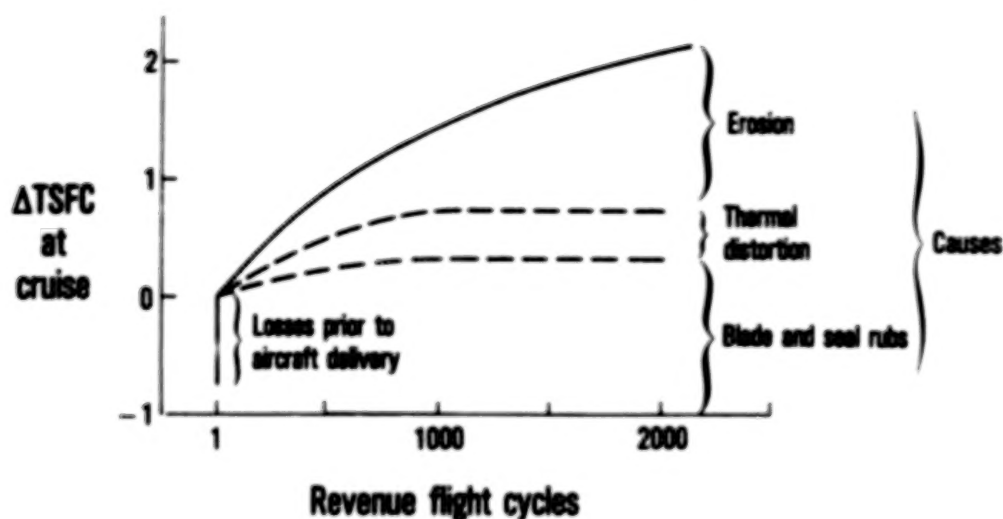
Figure 1 JT9D-7A In-Service Engine Performance Deterioration at Altitude Cruise Conditions. (J24873-2)

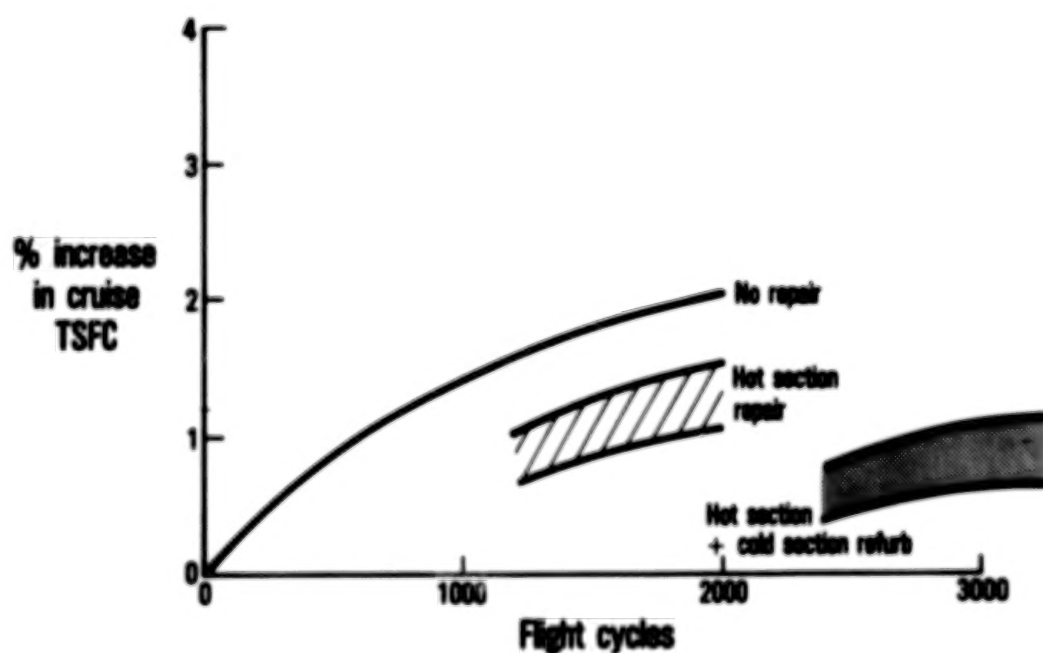
Figure 2 Effect of Repair on JT9D-7A Engine Cruise Thrust Specific Fuel Consumption. (J24603-24)

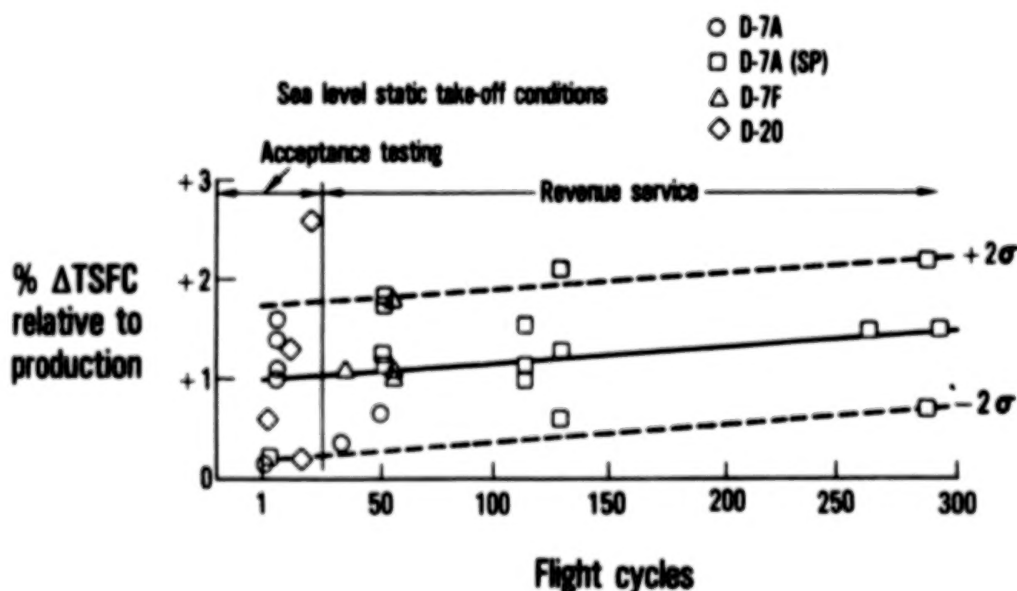
Figure 4 Historical Short-Term Deterioration Data.

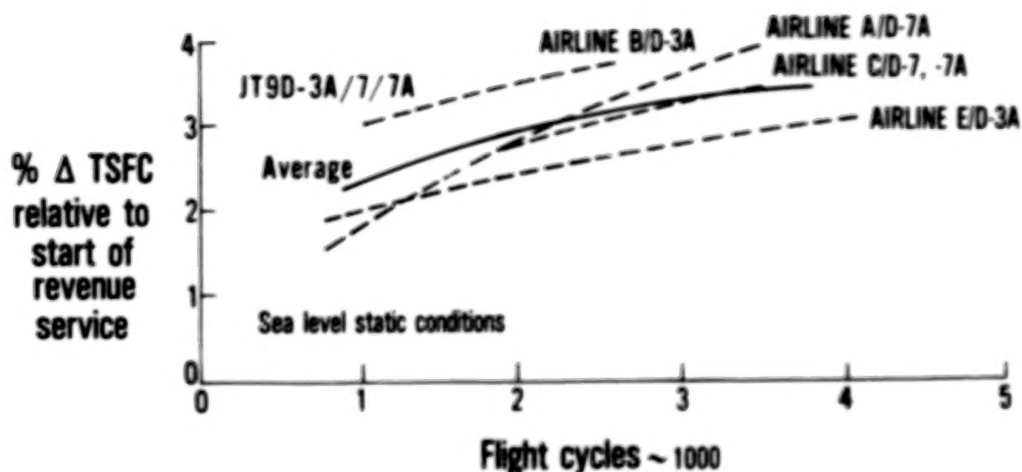
Figure 5 Historical Long-Term Deterioration Data for Unrepaired Engines.
(J24603-8)

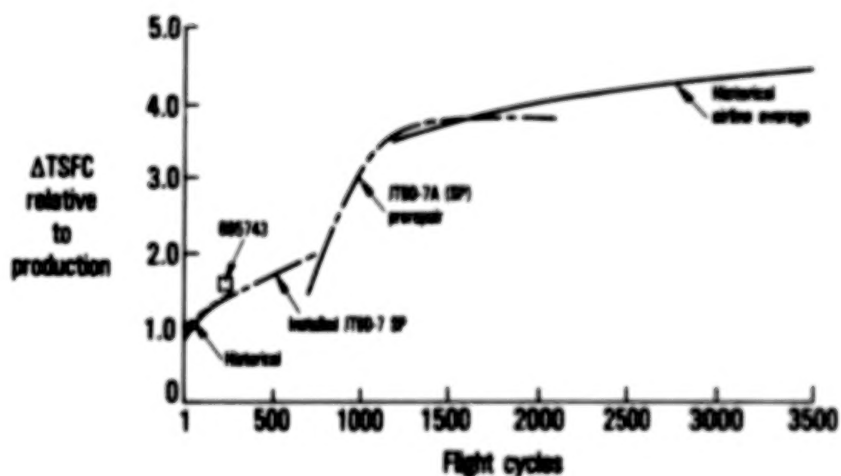
- Installed ground test from 0 — 1100 flight cycles
- Expanded testing and analytic teardown at 141 cycles
- Pre and post repair calibrations

Figure 6 Pan American 747SP/JT9D-7A In-Service Engine Performance Data.
(J24873-6)

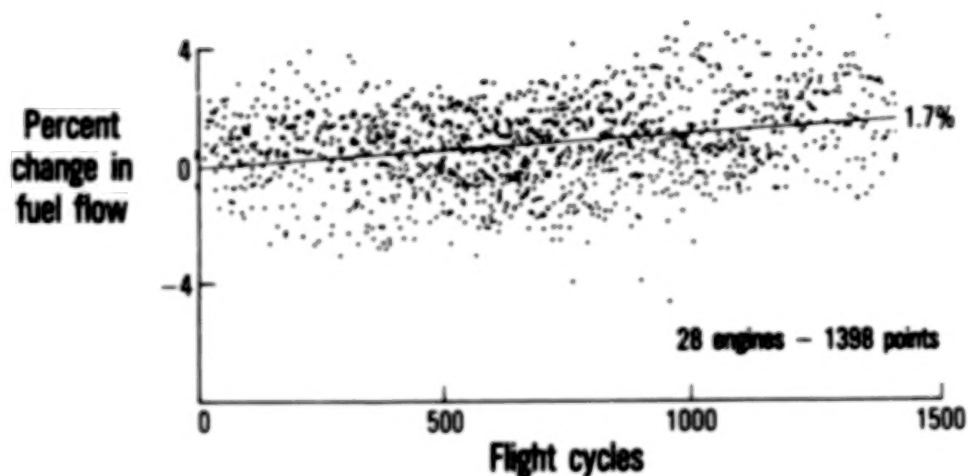
Figure 7 Cruise Fuel Flow Trend with Usage for Pan American 747SP/JT9D-7A Unrepaired Engines. (J24873-7)

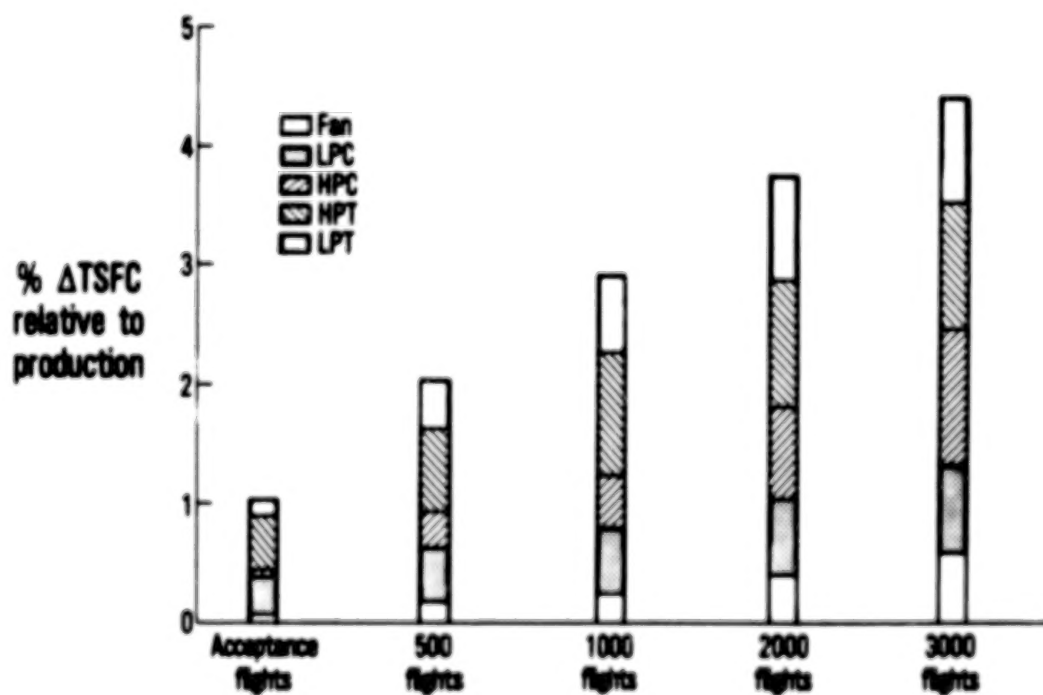
Figure 14 JT9D-7 Sea Level Performance Deterioration Distribution by Engine Module. (J24603-21)

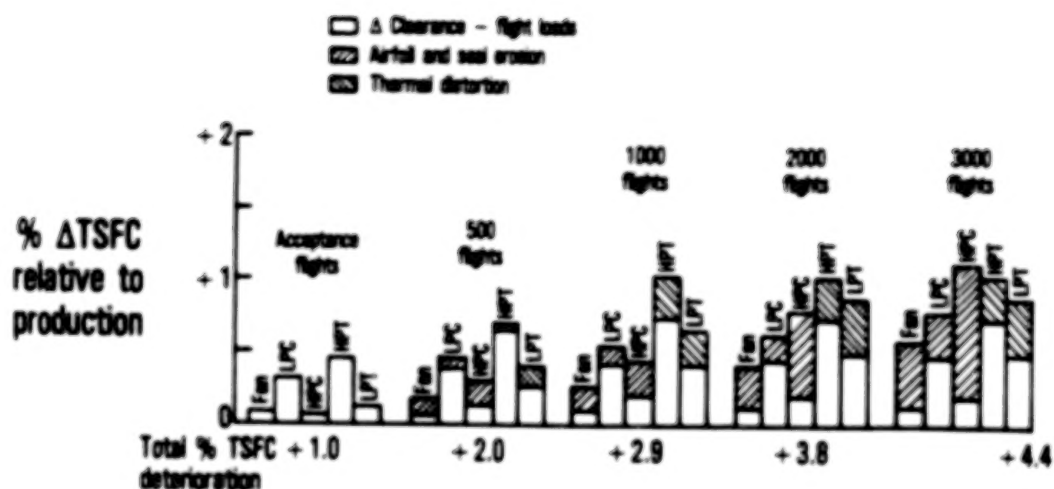
Figure 15 JT9D-7 Sea Level Performance Deterioration Distribution by Cause.
(J24603-23)

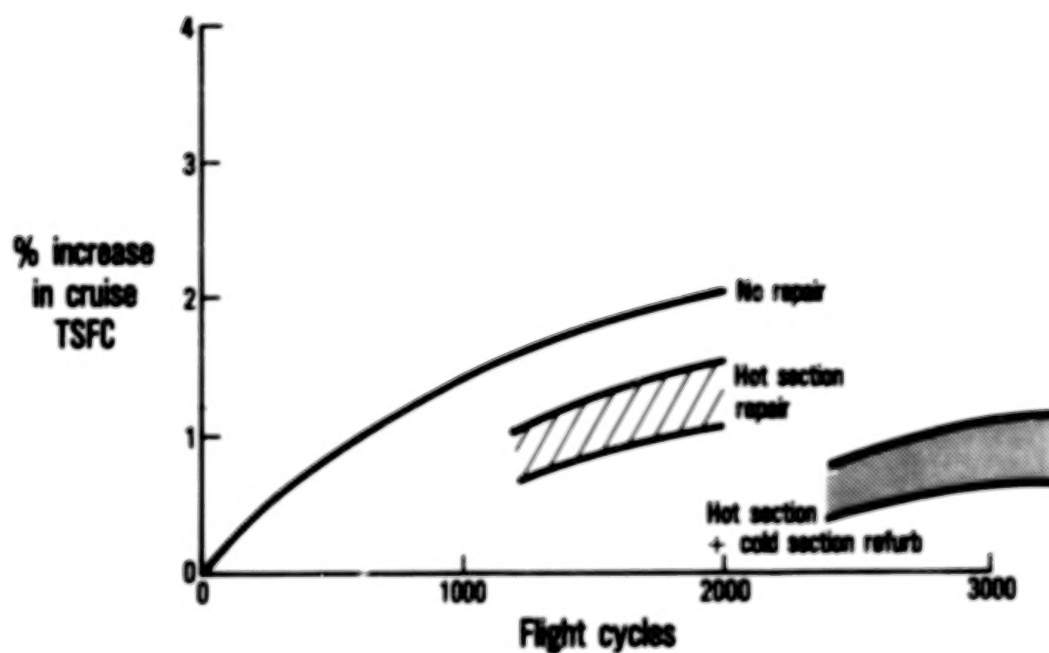
Figure 17 Effect of Repair on JT9D-7A Engine Cruise Thrust Specific Fuel Consumption. (J24603-24)

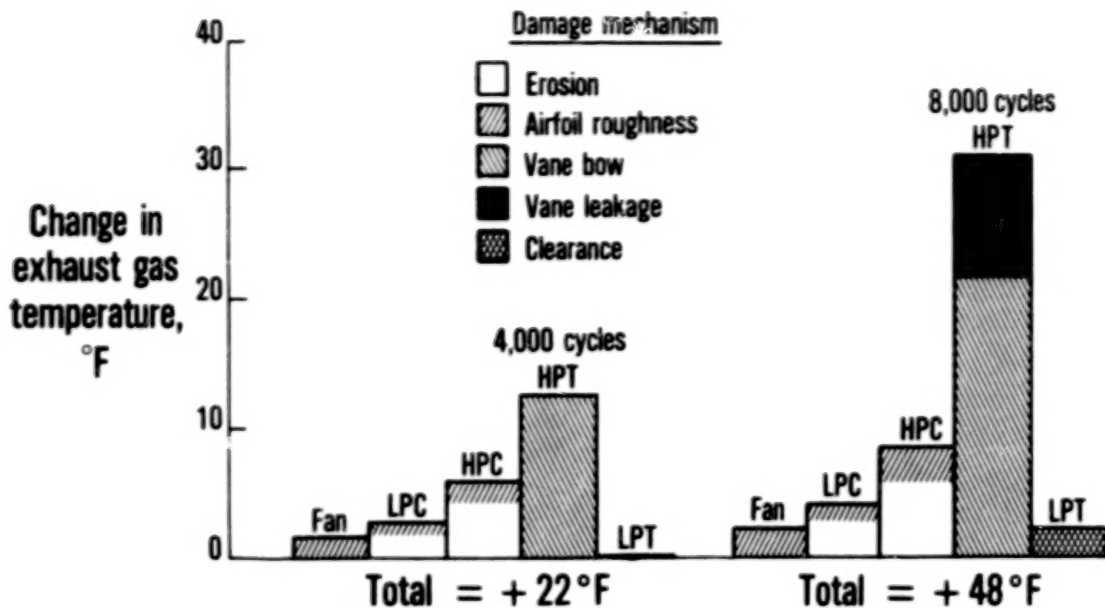
Figure 13 High Pressure Turbine Losses Major Cause of Exhaust Gas Temperature Increase

First run JT8D-9 engine model
30,000 ft alt/0.8 Mn/Std day/Constant thrust

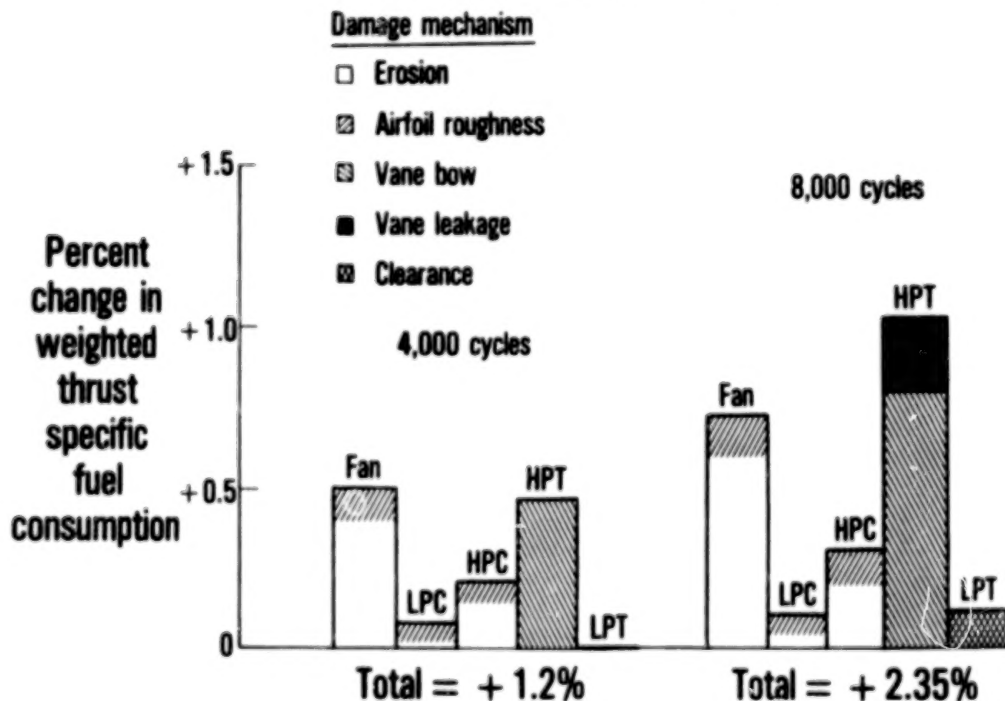
Figure 14 Cold Section Erosion and High Pressure Turbine Vane Bow Major Causes of Thrust Specific Fuel Consumption Loss

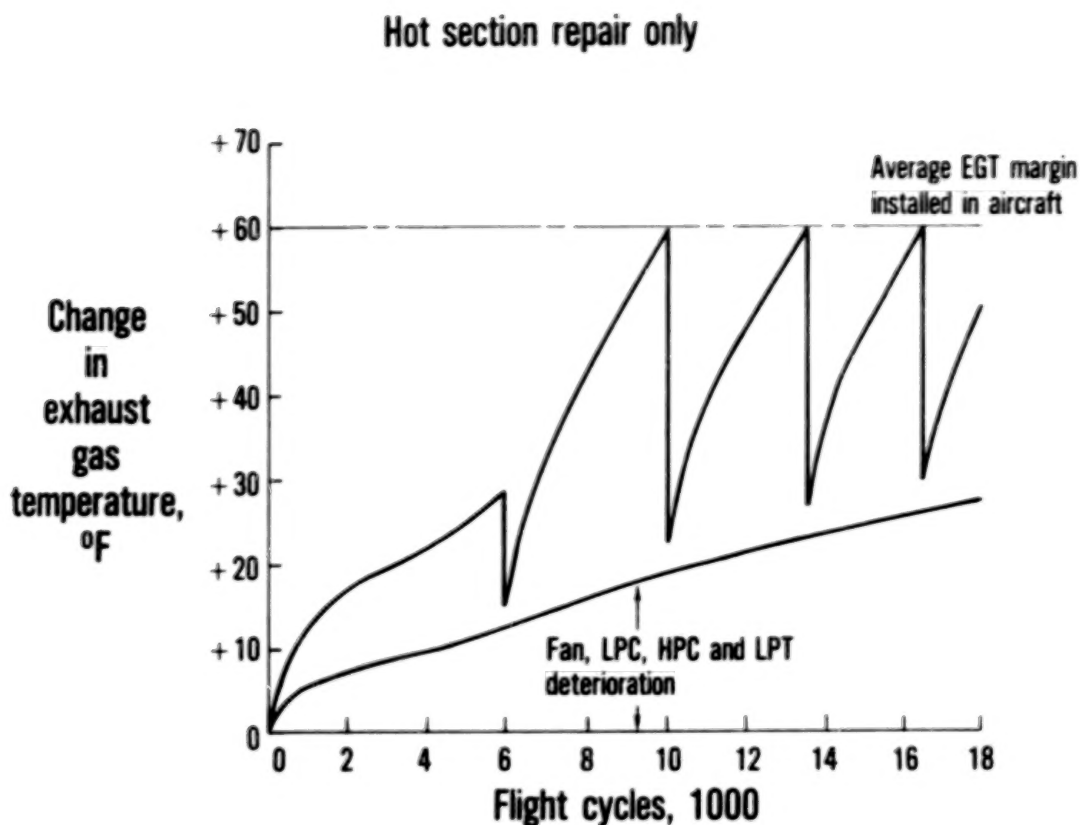
Figure 15 JT8D-9 Engine Multi-Run Model Projects Realistic Exhaust Gas Temperature-Limited Removals

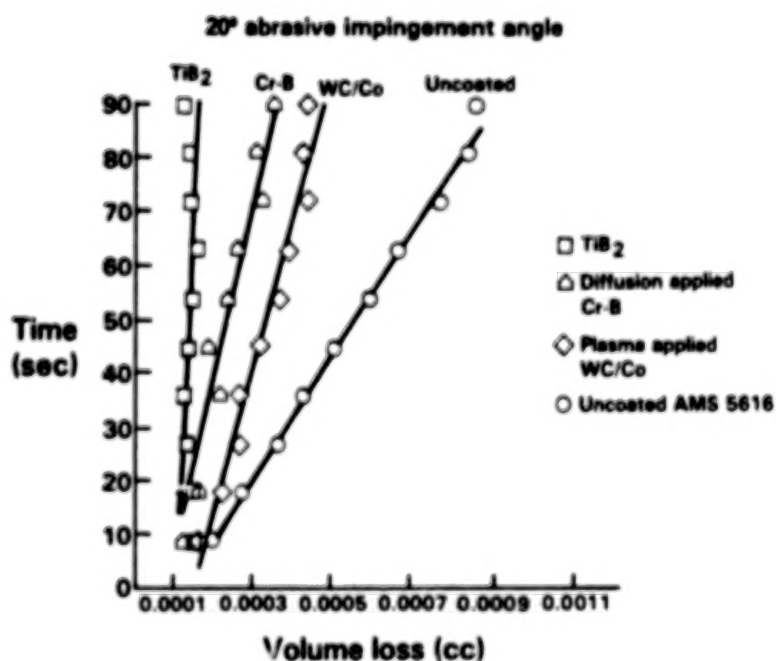
FIGURE 2 LABORATORY EROSION TEST RESULTS
ON COATED AMS 5616 STAINLESS STEEL

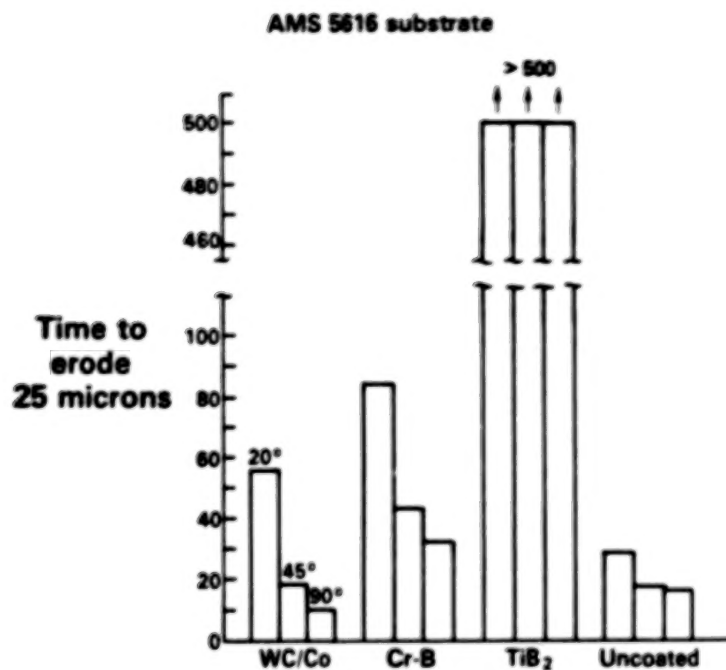
FIGURE 3 EROSION AS A FUNCTION OF ABRASIVE IMPINGEMENT ANGLE

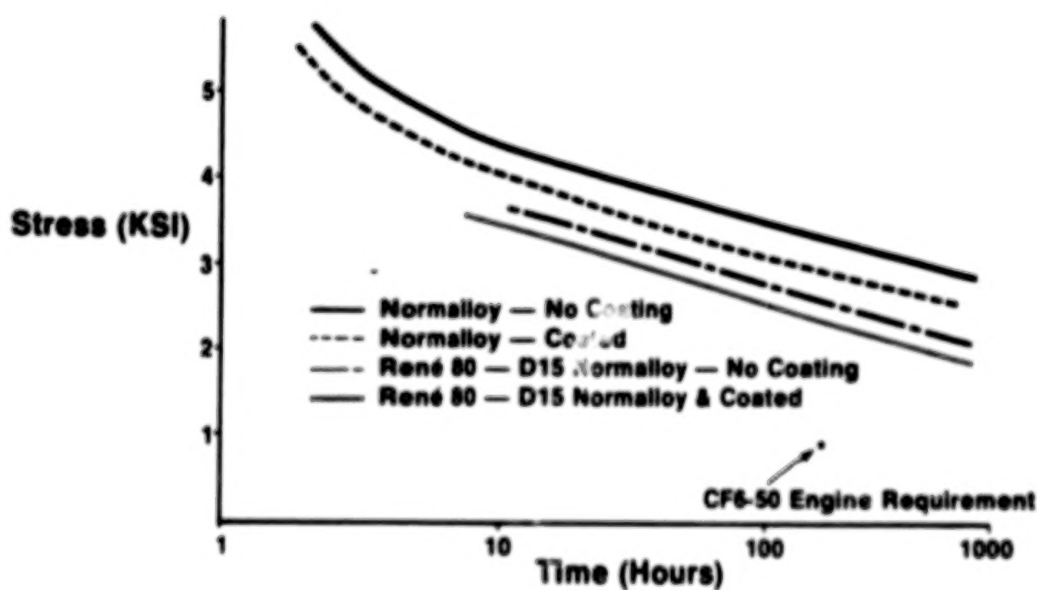
FIGURE 6. 2000F STRESS RUPTURE (AVERAGE)

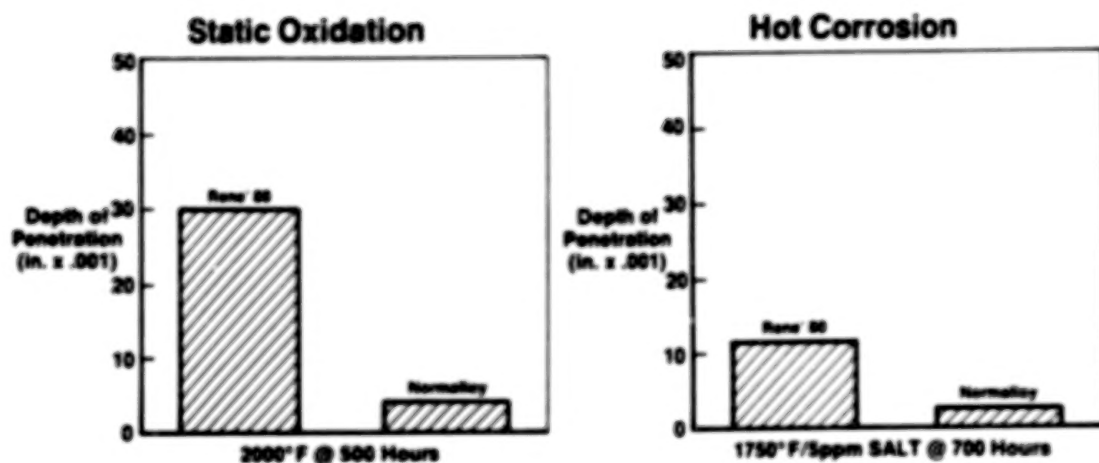
FIGURE 7. ELEVATED TEMPERATURE OXIDATION & CORROSION TESTING

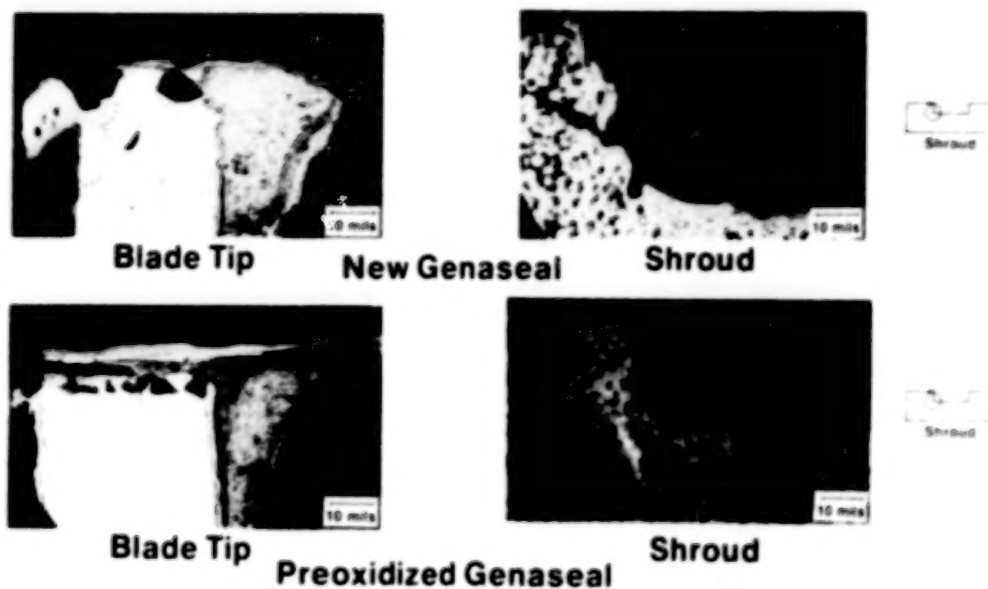
FIGURE 11. WEAR TESTING - ABRASIVE TIP INTO NEW & PREOXIDIZED GENASEAL

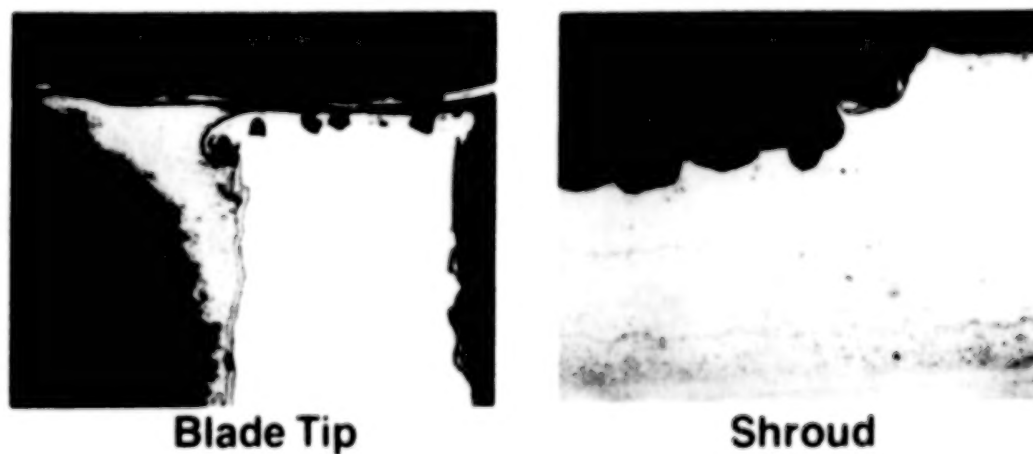
FIGURE 12. WEAR TESTING - ABRASIVE TIP INTO NEW VPD CONICRALL

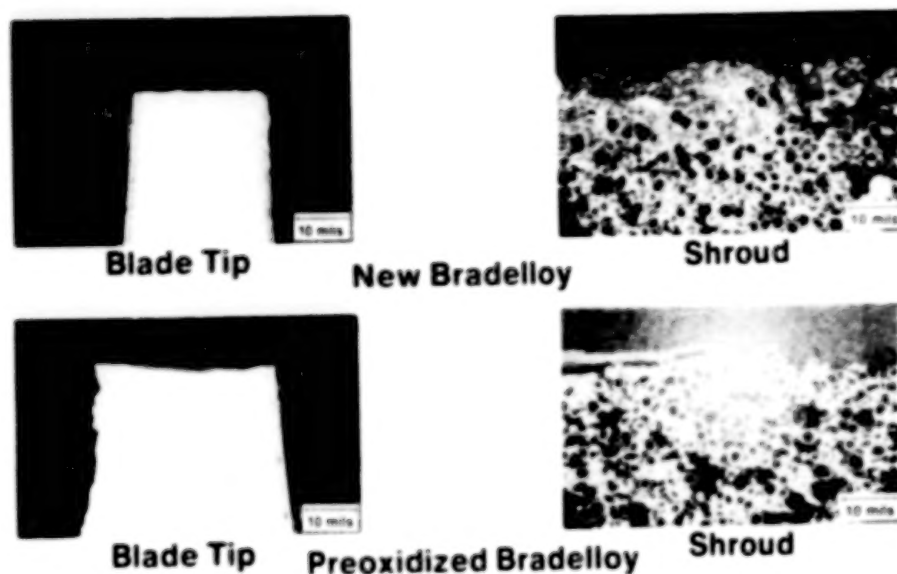
**FIGURE 13. WEAR TESTING - ABRASIVE TIP INTO NEW & PREOXIDIZED
BRADELLOY**

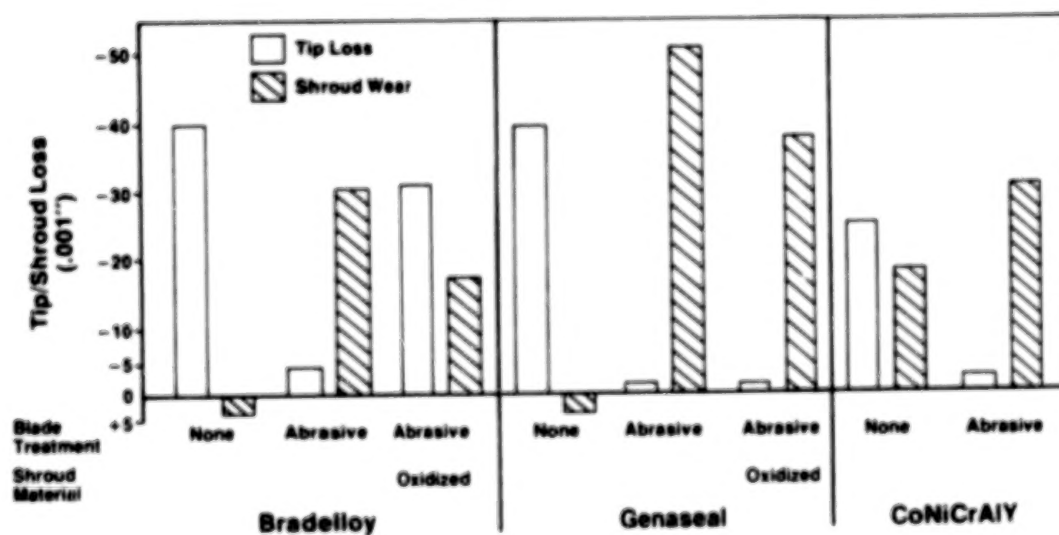
FIGURE 14. WEAR TEST RESULTS (2000F, 1400 ft/sec)

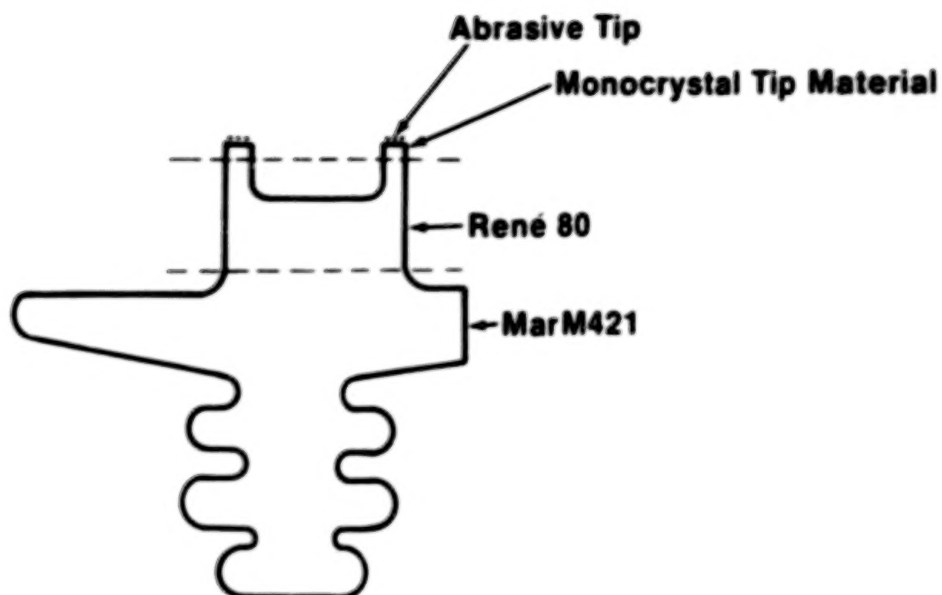
FIGURE 15. WEAR TEST SPECIMEN

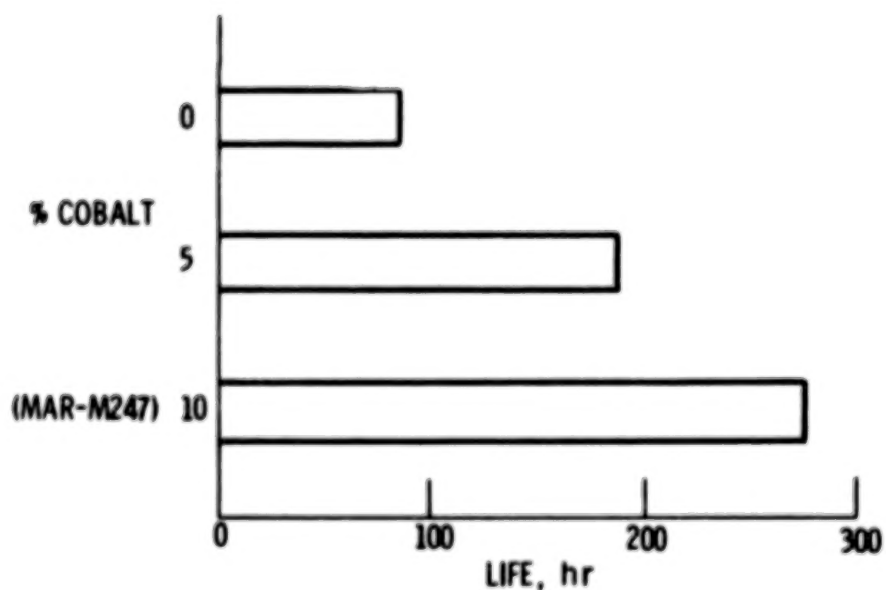
Figure 16. - Preliminary results of reducing cobalt in Mar-M247.
(Rupture life, 870° C; 360 MPa.)

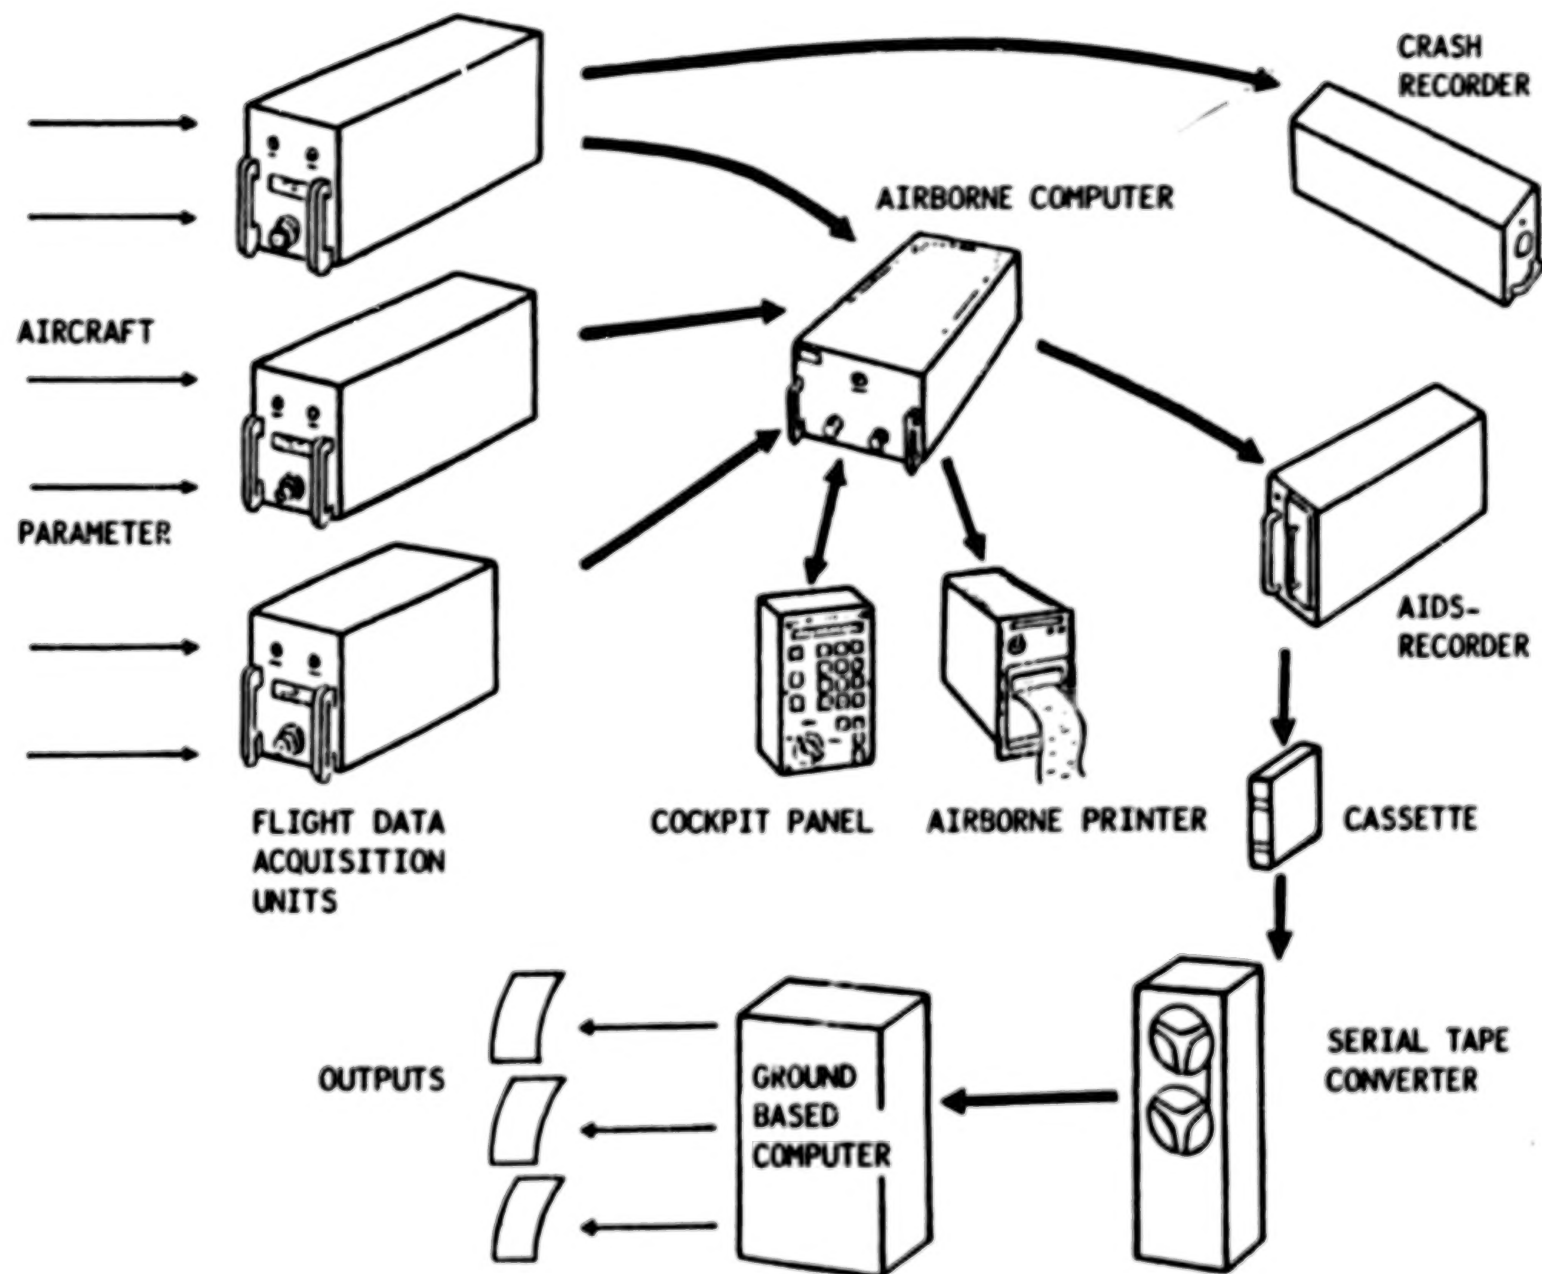
FIG. 1 AIDS SYSTEM AS INSTALLED IN KSS 747 AND DC-10 AIRCRAFT

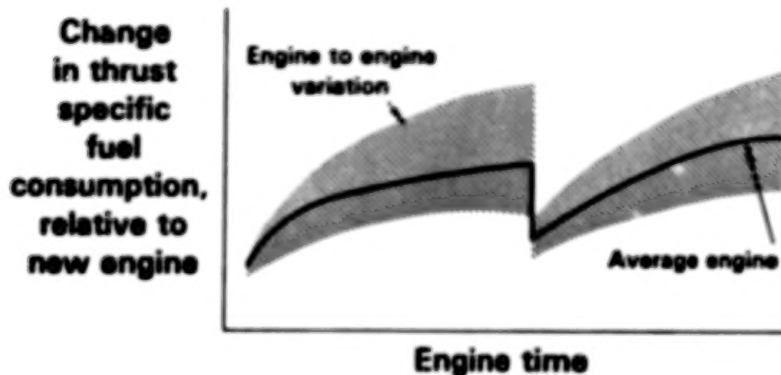
Figure 1 Typical Cycle of Engine Operation

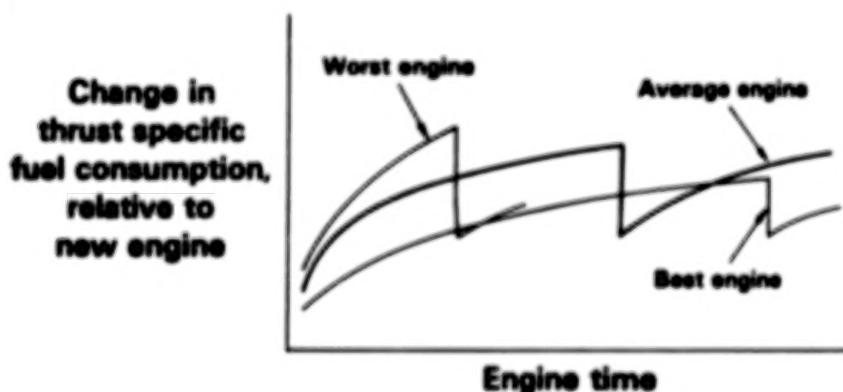
FUEL SAVINGS RESULT IF ENGINE REPAIR IS SCHEDULED BASED ON ACTUAL ENGINE CONDITION

Figure 2 Repair Schedules Customized for Worst and Best Engines Compared With Schedule Based on Average Engine

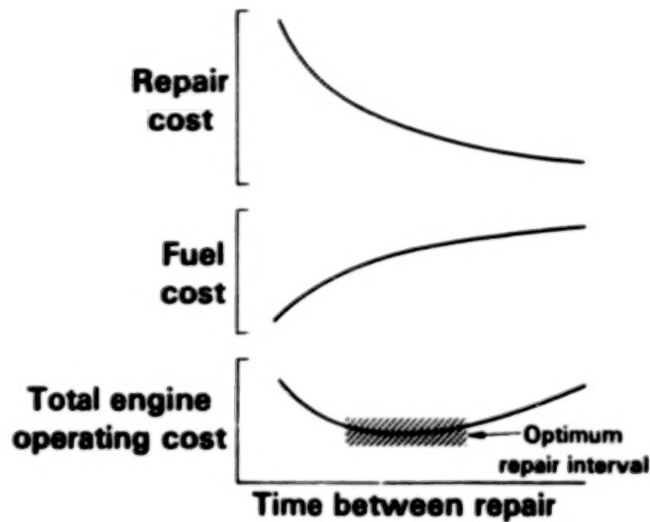
Figure 3 Effect of Time Between Repair on Repair Cost, Fuel Cost and Total Operating Cost

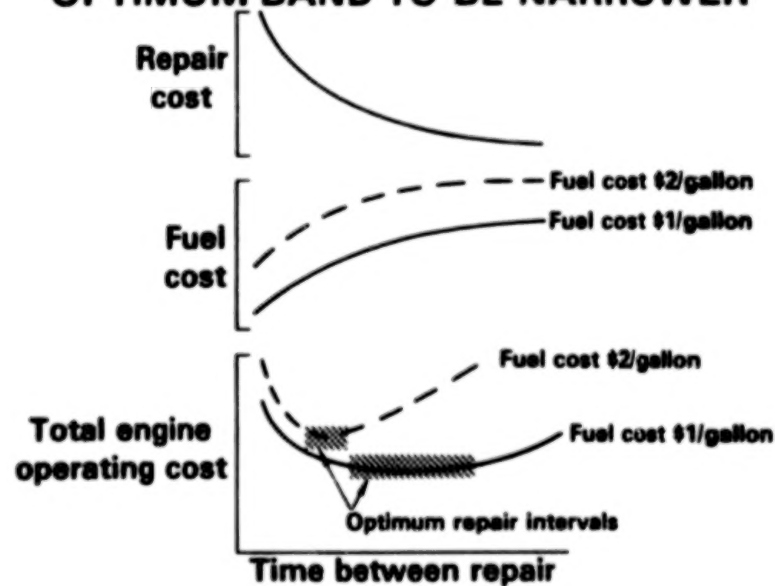
HIGHER FUEL COSTS CAUSE THE OPTIMUM REPAIR TIME TO BE SHORTER AND THE OPTIMUM BAND TO BE NARROWER

Figure 4 Effect of Fuel Cost on Optimum Repair Interval

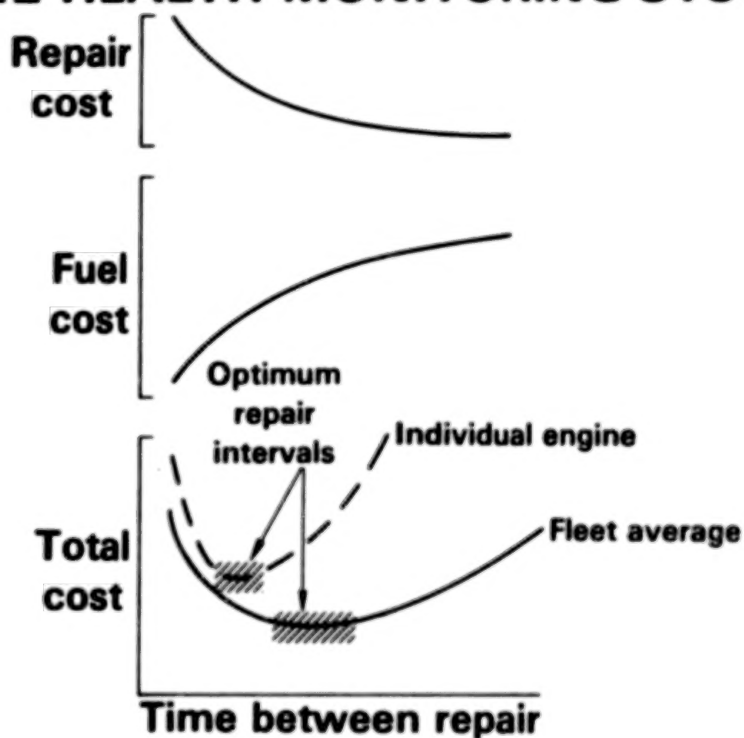
REPAIR POINT CAN BE OPTIMIZED FOR A PARTICULAR ENGINE WITH ENGINE HEALTH MONITORING SYSTEMS

Figure 5 Comparison of Optimum Repair Intervals for Individual and Fleet Average Engine
